# PLAY AREA SAFETY INSPECTION REPORT

Swardeston Parish Council

28 June 2016

Site Owner : **Swardeston Parish Council**  
Site Name : Swardeston PC  
Date of Inspection : 28 June 2016  
Inspected by : David Owen

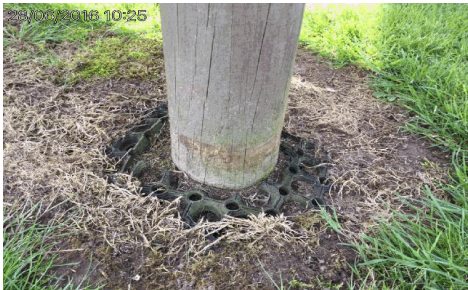
| Comments, action or control required | | Risk Level | Risk Score ± |
|---|---|---|---|
| Finding : | Strimmer damage to supports is likely to accelerate timber rot. | Low | 6 |

| Comments, action or control required | | Risk Level | Risk Score ± |
|---|---|---|---|
| Task : | Prevent further damage. | | |

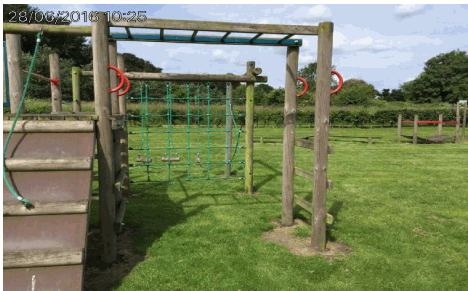
| Comments, action or control required | | Risk Level | Risk Score ± |
|---|---|---|---|
| Finding : | RoSPA is concerned by accidents on some types of overhead ladders and rings . There is, however, a strong development value in these items. | Medium | 8 |

| Comments, action or control required | | Risk Level | Risk Score ± |
|---|---|---|---|
| Task : | If possible, on angled or S shaped bars, consideration should be given to level bars with firm grips and even spacings. The protective surface under all bars and rings must be kept in good condition | | |

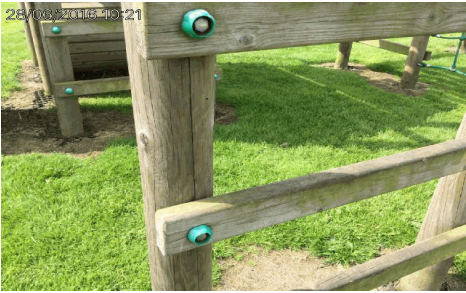
| <p>Finding : Item - Cap(s) missing</p> <p>Finding Date : 28/06/2016</p> | Low | 4 |

| <p>Task : Replace</p> <p>Finding : Paintwork in poor condition</p> <p>Finding Date : 28/06/2016</p> | Low | 5 |

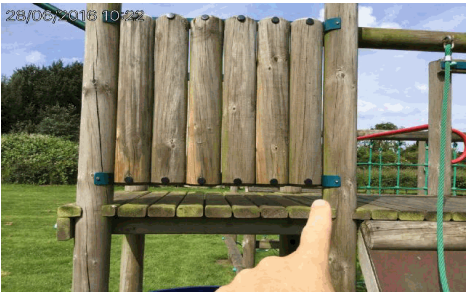
| <p>Task : De-scale and coat with lead free paint, using appropriate precautions</p> <p>Finding : Fixtures - Loose or Missing</p> <p>Finding Date : 28/06/2016</p> <p>Notes : Barrier fixings loose - tighten.</p> | Low | 5 |

| <p>Task : Tighten loose fixtures &amp; fittings</p> <p>Finding : There is decay to timber components which may affect structural integrity</p> <p>Finding Date : 28/06/2016</p> <p>Notes : Some support posts decayed and missing, allowing the ramp to be lifted - repair.</p> <p>Task : Replace decayed components where possible, and plan replacement of item.<br/>Check on a routine basis, especially at ground or foundation level</p> | Medium | 12 |

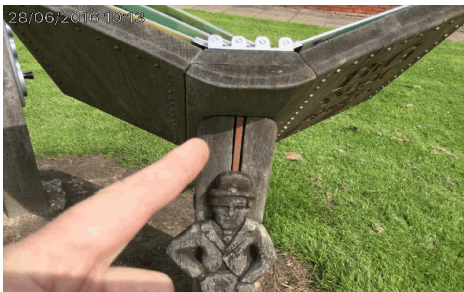
| Comments, action or control required | | Risk Level | Risk Score ‡ |
|---|---|---|---|
| Finding : | Item - Bolt(s) loose | Low | 6 |

| Comments, action or control required | | Risk Level | Risk Score ‡ |
|---|---|---|---|
| Task : | Tighten loose fixtures & fittings | | |

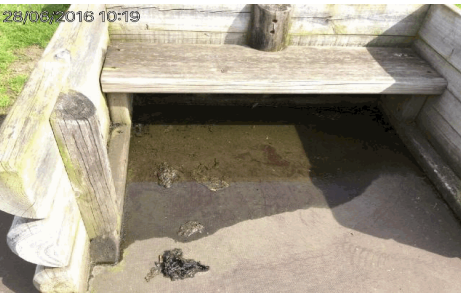
| Recommended Maintenance and Risk Assessment Evaluation | | Risk Level | Risk Score ‡ |
|---|---|---|---|
| Finding : | Other / Miscellaneous | Medium | 8 |
| Notes : | Decking holding water - install drainage holes to prevent standing water decaying timbers. | | |

| Recommended Maintenance and Risk Assessment Evaluation | | Risk Level | Risk Score ‡ |
|---|---|---|---|
| Task : | Refer to Inspection Notes / Description | | |

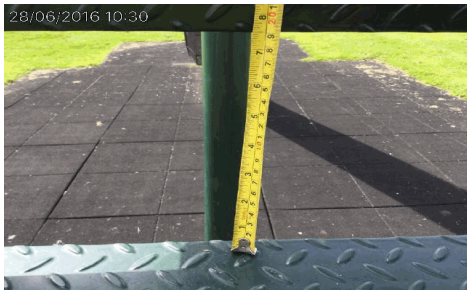
The item fails to meet the requirement of the relevant standard.

| Recommended Maintenance and Risk Assessment Evaluation | | Risk Level | Risk Score ± |
|---|---|---|---|
| Finding : | Access fails entrapment requirements | Low | 5 |

| Recommended Maintenance and Risk Assessment Evaluation | | Risk Level | Risk Score ± |
|---|---|---|---|
| Task : | Monitor and check on a routine basis | | |

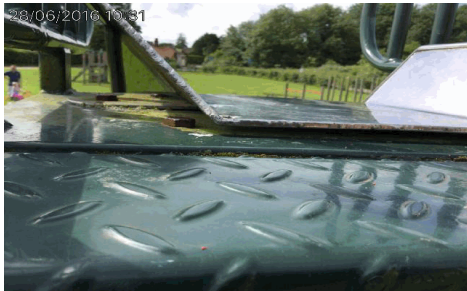
| Recommended Maintenance and Risk Assessment Evaluation | | Risk Level | Risk Score ± |
|---|---|---|---|
| Finding : | There is a toggle entrapment | | |

| Recommended Maintenance and Risk Assessment Evaluation | | Risk Level | Risk Score ± |
|---|---|---|---|
| Task : | Remove toggle entrapment | | |

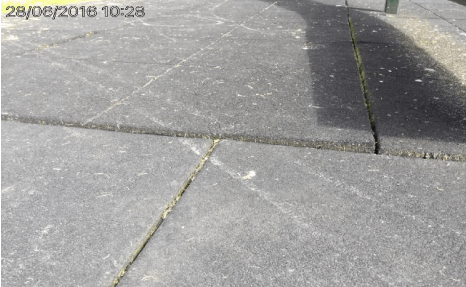
| Finding : Surface - Trip points | Low | 5 |
| Notes : Tiles lifting. | | |

| Task : Repair surface | | |

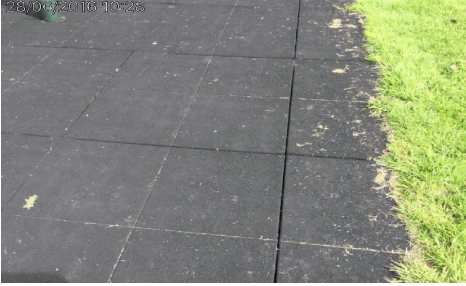
| Finding : Gaps have opened up between tiles causing trip hazard. | Low | 7 |

| Task : Re-fit tiles | | |

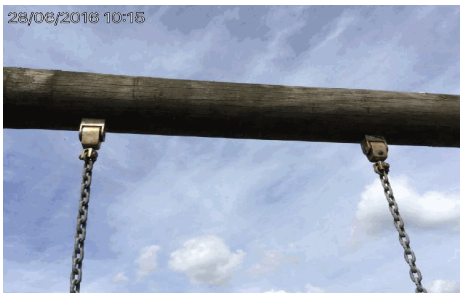
| Comments, action or control required | | Risk Level | Risk Score ± |
|---|---|---|---|
| Finding : | Item - Bolt(s) loose | Medium | 8 |
| Notes : | Re-tighten chain hanger bolts to the top bar. | | |

| Comments, action or control required | | Risk Level | Risk Score ± |
|---|---|---|---|
| Task : | Tighten loose fixtures & fittings | | |

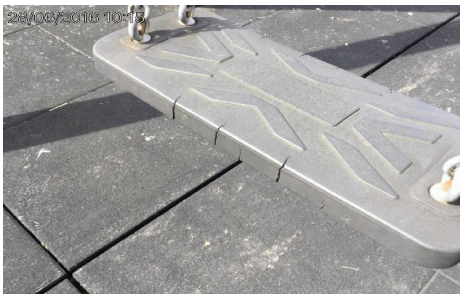
| Comments, action or control required | | Risk Level | Risk Score ± |
|---|---|---|---|
| Finding : | The swing seat has been damaged but does not require immediate replacement | Very Low | 3 |
| Notes : | Cracking. | | |

| Comments, action or control required | | Risk Level | Risk Score ± |
|---|---|---|---|
| Task : | Monitor and replace when hard material is exposed | | |

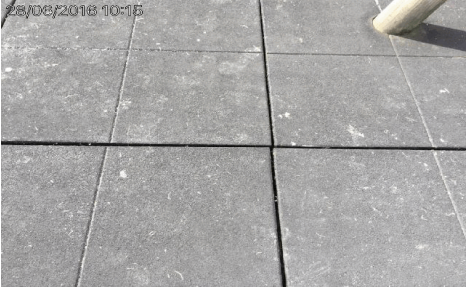
| <p>Finding : Surface - Tiles - Gaps</p> <p>Notes : Lift tiles, sweep bases, re-lay and glue together, then infill perimeter with extra timber edgings.</p> <p>Task : Close / fill gaps</p> | Low | 7 |

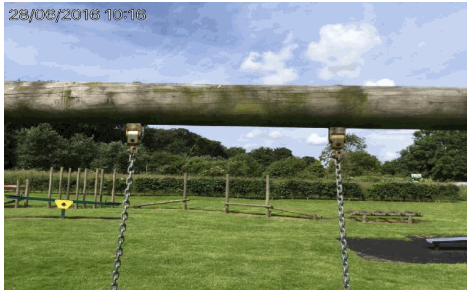
| Recommended Maintenance and Risk Assessment Evaluation | | Risk Level | Risk Score ‡ |
|---|---|---|---|
| Finding : | Item - Bolt(s) loose | Medium | 12 |

| Recommended Maintenance and Risk Assessment Evaluation | | Risk Level | Risk Score ‡ |
|---|---|---|---|
| Task : | Tighten loose fixtures & fittings | | |

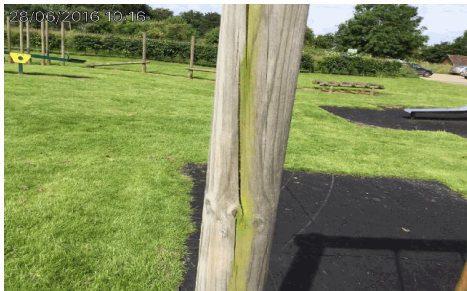
| Recommended Maintenance and Risk Assessment Evaluation | | Risk Level | Risk Score ‡ |
|---|---|---|---|
| Finding : | Timber - Laminates - Splits | | |
| Notes : | Monitor timber splits. | Low | 6 |

| Recommended Maintenance and Risk Assessment Evaluation | | Risk Level | Risk Score ‡ |
|---|---|---|---|
| Task : | Seal laminated timber edges to prevent water ingress | | |

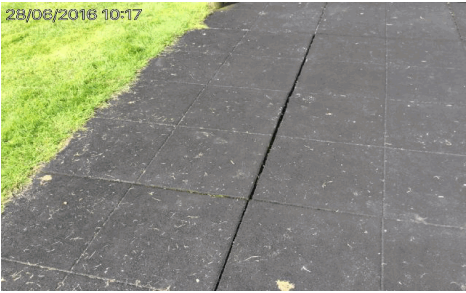
| <p>Finding : Surface - Tiles - Gaps</p> <p>Task : Close / fill gaps</p> | Low | 6 |

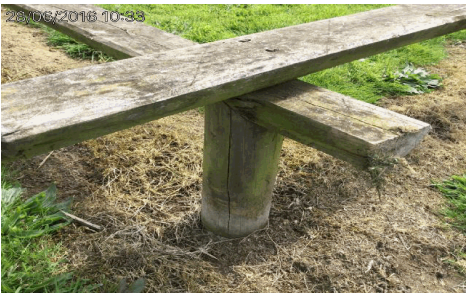
| Comments, action or control required | | Risk Level | Risk Score ± |
|---|---|---|---|
| Finding : | Timber - Not in Good Condition | Low | 7 |
| Notes : | Balance beam x 1. | | |

| Comments, action or control required | | Risk Level | Risk Score ± |
|---|---|---|---|
| Task : | Replace worn parts | | |

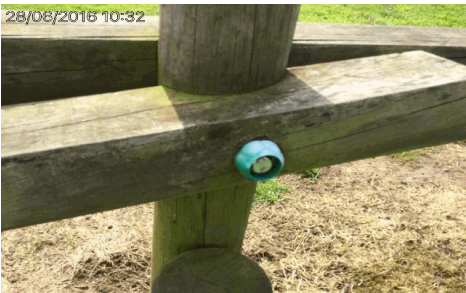
| Comments, action or control required | | Risk Level | Risk Score ± |
|---|---|---|---|
| Finding : | Item - Cap(s) missing | Very Low | 3 |

| Comments, action or control required | | Risk Level | Risk Score ± |
|---|---|---|---|
| Task : | Replace | | |

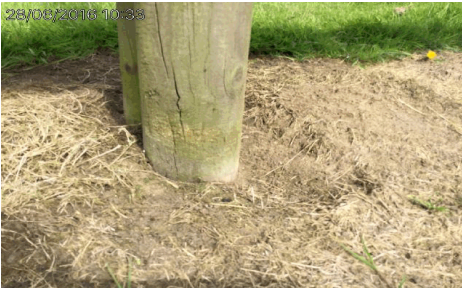
| <p>Finding :            <b>Strimmer damage to supports is likely to accelerate timber rot.</b></p> <div data-bbox="630 309 1094 595"> </div> <p>Task :                <b>Prevent further damage.</b></p> | <p>Low</p> | <p>6</p> |
