# PLAY AREA SAFETY INSPECTION REPORT

Swardeston Parish Council

28 June 2016

Site Owner : **Swardeston Parish Council**  
Site Name : Swardeston PC  
Date of Inspection : 28 June 2016  
Inspected by : David Owen

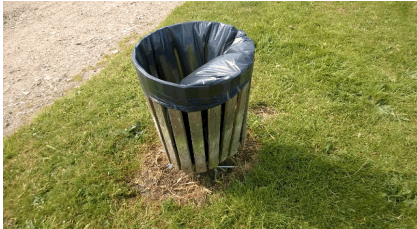
| Facilities | | | | |
|---|---|---|---|---|
| Litter Bin<br><br>Risk Score : 3<br>Risk Level : Very Low | Bins | Satisfactory<br><br> | | |

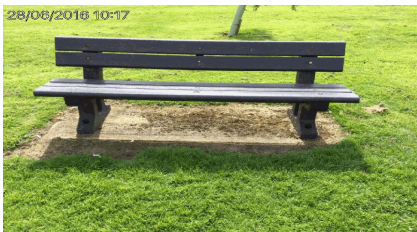
| Facilities | | | | |
|---|---|---|---|---|
| Seating - Bench<br><br>Risk Score : 3<br>Risk Level : Very Low | Seating | Satisfactory<br><br> | | |

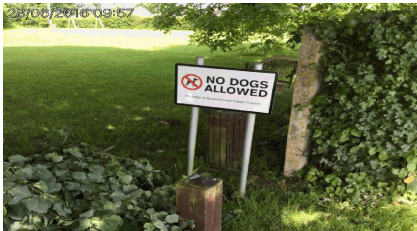
| Facilities | | | | |
|---|---|---|---|---|
| Sign<br><br>Risk Score : 2<br>Risk Level : Very Low | Signage | Satisfactory<br><br> | | |

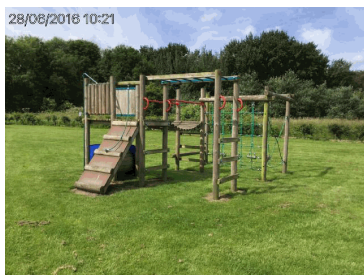
## Climber - Multi

Risk Level : Medium  
Risk Score : 8

| Comments, action or control required | | Risk Level | Risk Score ± |
|---|---|---|---|
| Finding : | Strimmer damage to supports is likely to accelerate timber rot. | Low | 6 |

| Comments, action or control required | | Risk Level | Risk Score ± |
|---|---|---|---|
| Task : | Prevent further damage. | | |

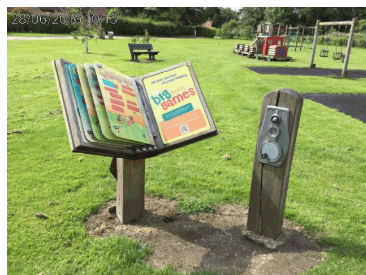
## Play Feature - The Big Book of Games

Risk Level : Very Low  
Risk Score : 3

| Comments, action or control required | | Risk Level | Risk Score ‡ |
|---|---|---|---|
| Finding : | Item - Bolt(s) loose | Low | 6 |

| Comments, action or control required | | Risk Level | Risk Score ‡ |
|---|---|---|---|
| Task : | Tighten loose fixtures & fittings | | |

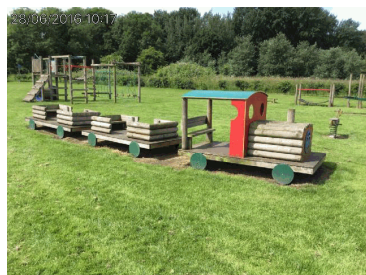
## Play Train

Risk Level : Very Low  
Risk Score : 3

| Recommended Maintenance and Risk Assessment Evaluation | | Risk Level | Risk Score ‡ |
|---|---|---|---|
| Notes : | Decking holding water - install drainage holes to prevent standing water decaying timbers. | | |

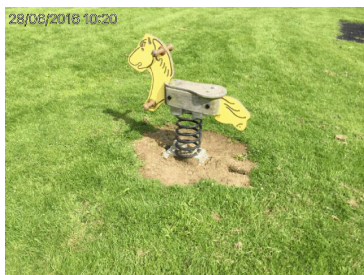
## Rocker - Horse

Risk Level : Very Low

Risk Score : 3

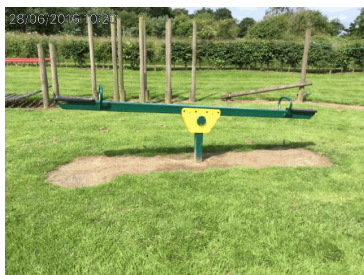
## Rocker - Seesaw

Risk Level : Very Low

Risk Score : 3

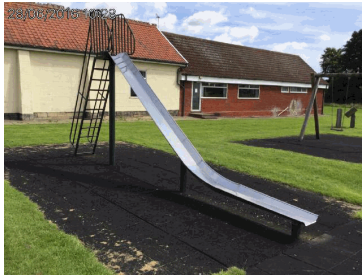
## Slide

Risk Level : Low  
Risk Score : 5

The item fails to meet the requirement of the relevant standard.

| Recommended Maintenance and Risk Assessment Evaluation | | Risk Level | Risk Score ± |
|---|---|---|---|
| Finding : | Access fails entrapment requirements | Low | 5 |

| Finding : Gaps have opened up between tiles causing trip hazard. | Low | 7 |

| Task : Repair surface | | |

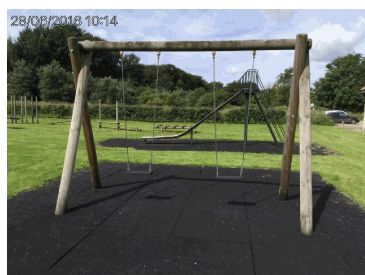
## Swing - Junior - 1 Bay 2 Seat

Risk Level : Low  
Risk Score : 6

| Comments, action or control required | | Risk Level | Risk Score ± |
|---|---|---|---|
| Finding : | Item - Bolt(s) loose | Medium | 8 |
| Finding : | The swing seat has been damaged but does not require immediate replacement | Very Low | 3 |
| Notes : | Cracking. | | |

| Comments, action or control required | | Risk Level | Risk Score ± |
|---|---|---|---|
| Task : | Tighten loose fixtures & fittings | | |
| Task : | Monitor and replace when hard material is exposed | | |

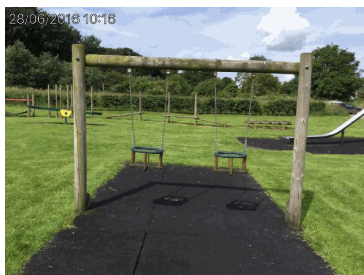
## Swing - Toddler - 1 Bay 2 Seat

Risk Level : Low  
Risk Score : 4

| Recommended Maintenance and Risk Assessment Evaluation | | Risk Level | Risk Score ‡ |
|---|---|---|---|
| Finding : | Item - Bolt(s) loose | Medium | 12 |

| Recommended Maintenance and Risk Assessment Evaluation | | Risk Level | Risk Score ‡ |
|---|---|---|---|
| Task : | Tighten loose fixtures & fittings | | |

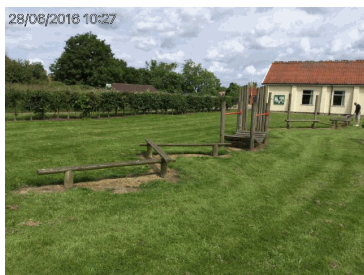
## Trim Trail - 5 Items

Risk Level : Very Low  
Risk Score : 3

| Comments, action or control required | | Risk Level | Risk Score ± |
|---|---|---|---|
| Finding : | Timber - Not in Good Condition | Low | 7 |
| Finding : | Item - Cap(s) missing | Very Low | 3 |
| Finding : | Cap missing | Low | 6 |

| Comments, action or control required | | Risk Level | Risk Score ± |
|---|---|---|---|
| Task : | Replace worn parts | | |
| Task : | Replace | | |
| Task : | Check security of fixings and replace bolt/nut cap | | |
